BRUSHY CREEK TAILINGS DAM

MO 30951

PHASE I INSPECTION REPORT
NATIONAL DAM SAFETY PROGRAM
BRUSHY CREEK TAILINGS DAM - MO. 30951

Name of Dam:	Brushy Creek Tailings Dam
State Located:	Missouri
County Located:	Reynolds County (Mark Twain National Forest)
Stream:	Schoolhouse Branch of Bill's Creek
Date of Inspection:	15 November 1978

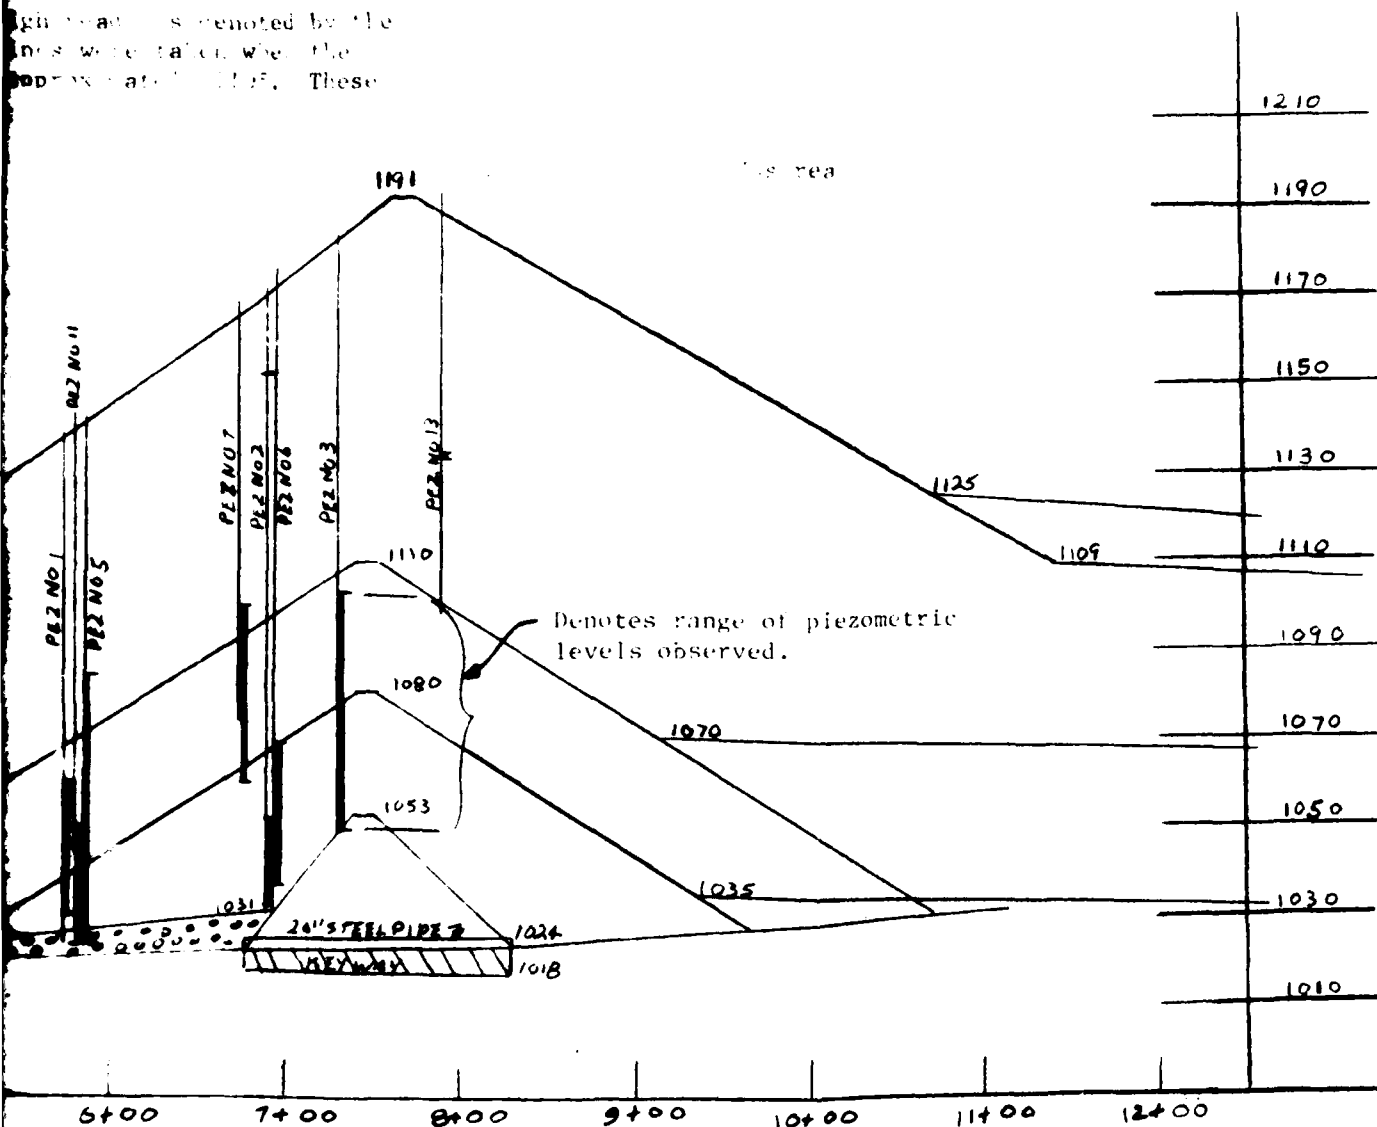
Embankment cross-section showing range of piezometer readings.

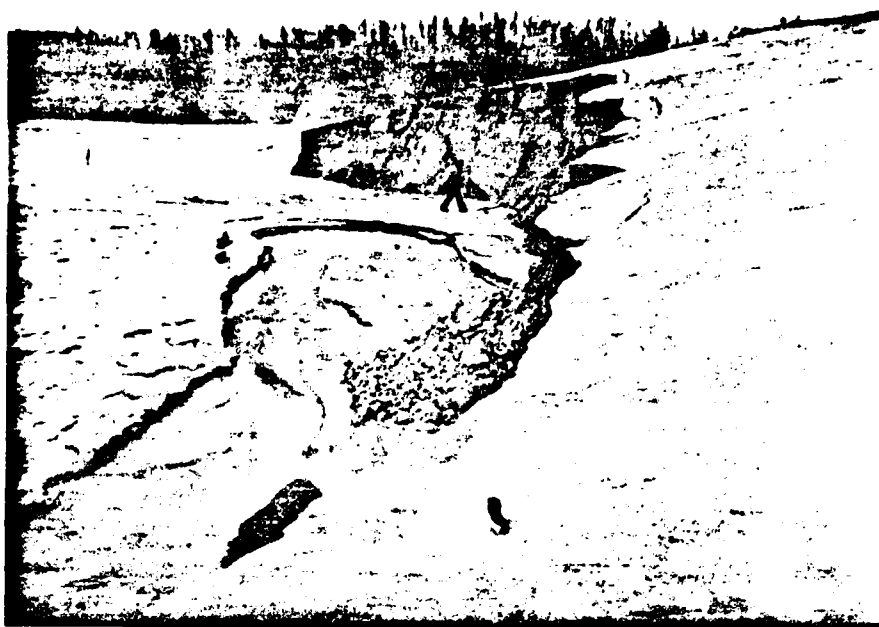
As noted in Section 3.1.e., the hydraulic method of tailings deposition causes severe erosion on the upstream dam face (Photo 5). Efforts to minimize this erosion should be implemented. Additionally, sufficient freeboard between the reservoir water surface and the fine tailings deposition area (See Plate 3) should be maintained to prevent a free pool surface from resting against the upstream dam slope. Without such a precaution, wave erosion may result and the embankment seepage conditions would be altered significantly.

PHOTO 5: Upstream slope with scarp created by erosion due to hydraulic method of tailings deposition
